# **Oxidizer Decontamination of Building Materials Contaminated with Methamphetamine**

John W. Martyny, Ph.D., CIH  
Associate Professor  
National Jewish Medical and Research Center  
Division of Environmental and Occupational Health Sciences

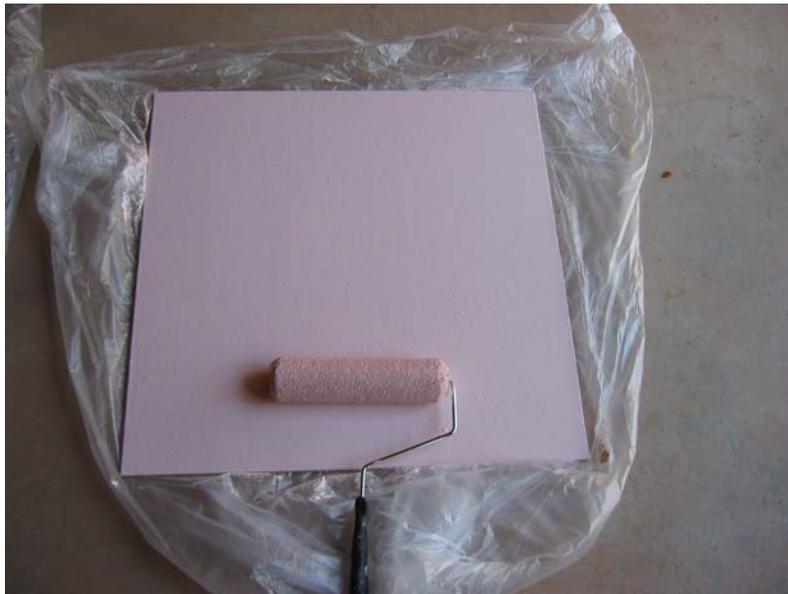
Figure 1. Painting drywall with a base paint prior to contaminating the board in the chamber.

This study was conducted to determine the impact of washing painted drywall surfaces with a cleaner containing an oxidizing compound. The drywall utilized in this project was 3/8<sup>th</sup> inch gypsum board that was cut into 24" x 24" squares. The drywall was painted with a latex enamel paint by painting the surface with two coats of paint, letting the paint dry and then painting it again with the same latex paint. Good coverage was provided and a gallon of paint was found to cover a total of 16 panels. After the painting, the paint was allowed to dry for a period of at least 2 days prior to contaminating the panels with methamphetamine.

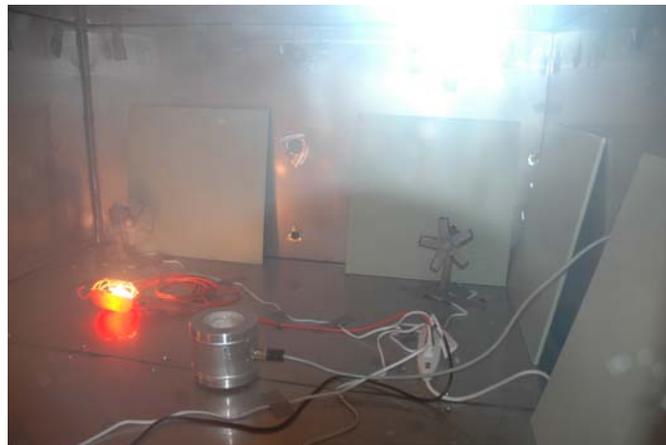
Figure 2. Painted drywall material being contaminated within the chamber.

After painting, the drywall panels were put into the chamber for contamination. A total of 9 drywall panels were contaminated on September 21, 2008 using 206 mg of methamphetamine. The methamphetamine was aerosolized starting at 12:40 pm and the

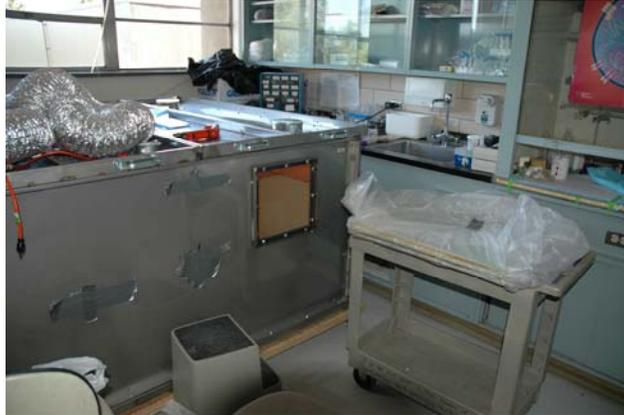
Figure 3. Drywall being removed for transportation to an area to be sampled and treated.

After the material was removed from the chamber, it was placed in a plastic bag and transported to an area to be pre-sampled, washed, and post sampled.

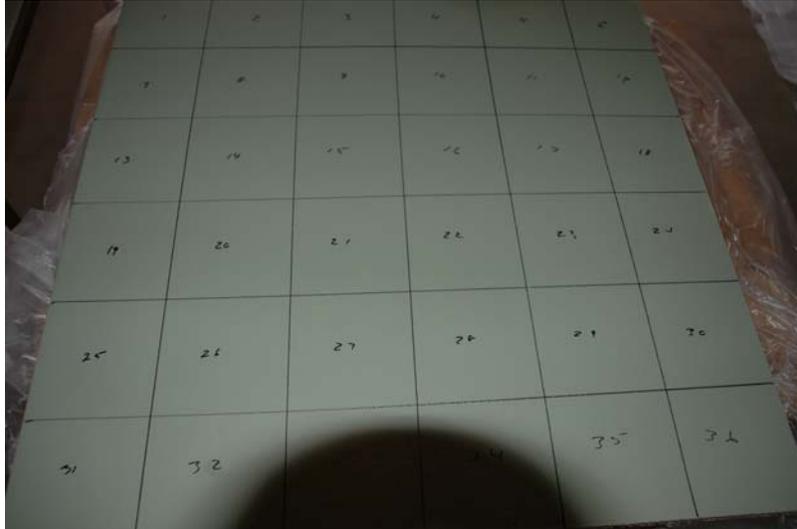
Figure 4. Panel prepared for initial pre-sampling after contamination.

For each panel, there were a total of 36 potential 100 cm<sup>2</sup> samples available. The squares sampled were determined using random number generator for each panel using numbers from 1 – 36. The two groups of 5 samples were generated with no replicates and the position of the samples were located on the panel using the following template:

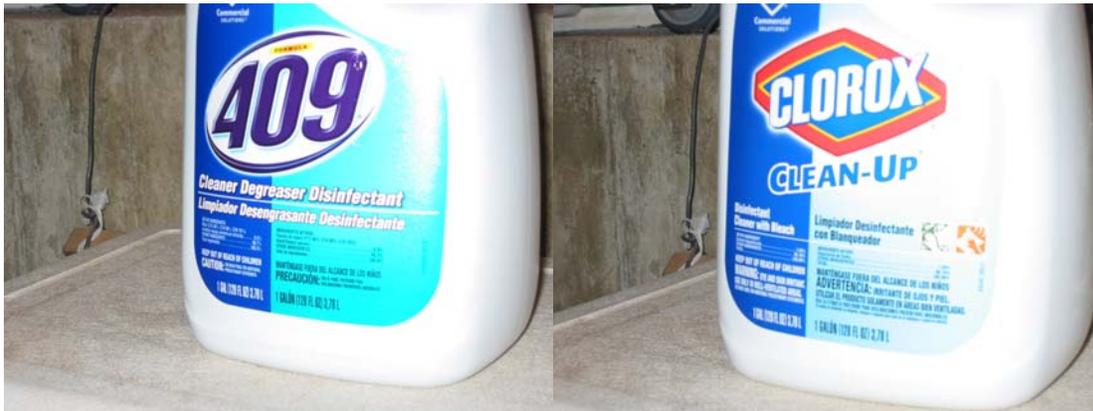
Figure 5. Pictures of the oxidizer cleaners utilized during this experiment.

The 409 cleaner contained 0.3% of alkyl dimethyl benzyl ammonium chloride and the Clorox Clean-Up contained 1.84% of sodium hypochlorite. Both products are manufactured by Clorox Corporation and are sold in retail outlets. The Material Safety Data Sheets for these products are attached to this report.

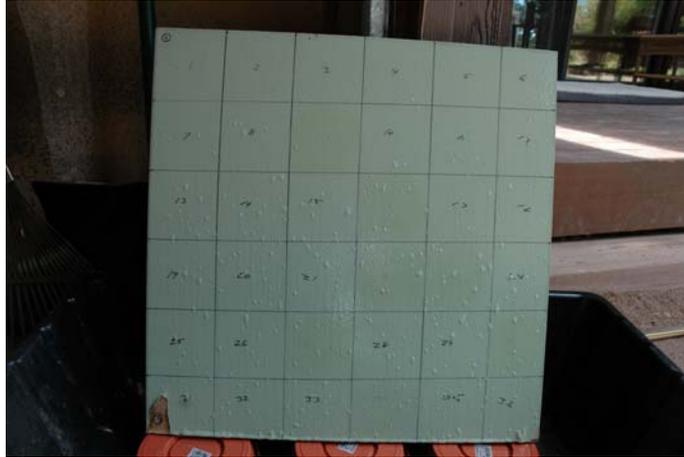
Figure 5. Washing the panel with the oxidizer solutions.

After the collection of the pre-samples, the panels were then washed for the prescribed number of treatments using the appropriate cleaner. The cleaner was used according to label directions for a maximum degreasing. The cleaner was applied full-strength from a spray bottle onto the surface of the panel. The cleaner was allowed to sit on the panel for approximately 1.5 minutes and then it was washed off using clean water and a cloth. The surface was not scrubbed hard and no abrasive materials were utilized. After cleaning, the panels were allowed to dry completely before subsequent cleanings or prior to post sampling.

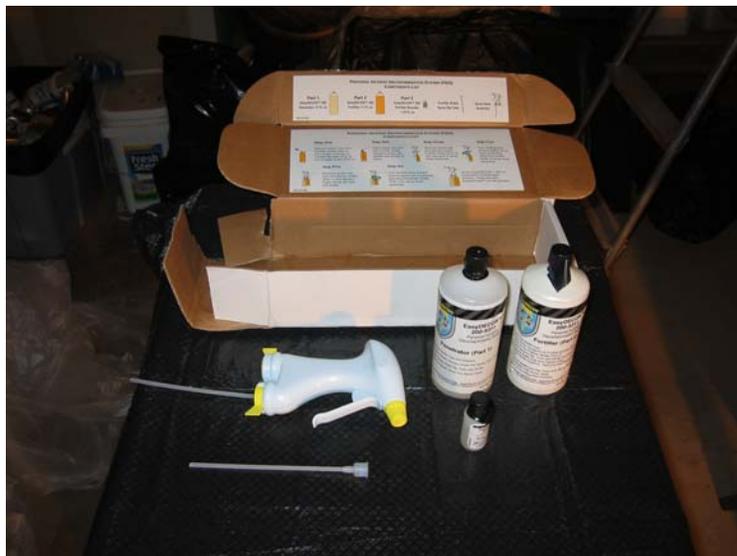
Figure 6. The EasyDECON kit containing the three-part decontamination material prior to assembly.

On January 19, 2009 the third experiment was conducted to determine if an oxidizing agent supplied by EFT Holdings Inc. and developed by Sandia National Laboratories would also be effective in reducing methamphetamine levels on painted drywall. This compound is labeled as EasyDECON and is supplied in three parts by the manufacturer. The three parts include a Penetrator that is a quaternary ammonium product, a Fortifier that is a liquid hydrogen peroxide, and a Booster that is labeled as a diacetin in the MSDS. The three parts are added together immediately prior to spraying them onto the surface. The manufacturer also does not require that the compounds be removed from the surface but does require a 30 minute contact time in which the surface must be wet. The product is a foamy material when applied to the surface.

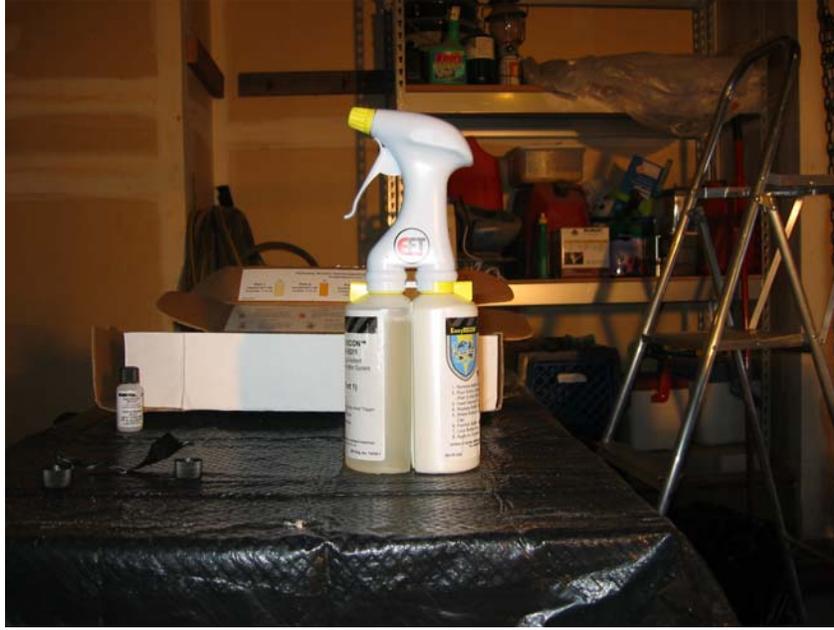
Figure 7. The EasyDECON solution application unit after assembly and prior to surface treatment.

This portion of the experiment was conducted in the same manner as the above two oxidizers except that the product was applied with the spray bottle that was provided and then let sit for a period of at least 30 minutes in a wet state. The product was then allowed to dry and the samples were collected in the same manner as in the previous samples. Samples were only taken from the painted drywall material. Seven samples were collected prior to treatment and after treatment, resulting in a total of 14 samples being taken from each of the drywall panels. Each sample consisted of a 100 cm<sup>2</sup> area being sampled from the panel using a 3"x 3" cotton swab to which 3 ml of methanol were added. After sampling the wipe was then put into a plastic centrifuge tube and sent to the laboratory for analysis as in the previous testing.
